MISSISSIPPI ENVIRONMENTAL GEOLOGY

David T. Dockery III and David E. Thompson

Mississippi Department of Environmental Quality
Office of Geology
Second Edition, 2019

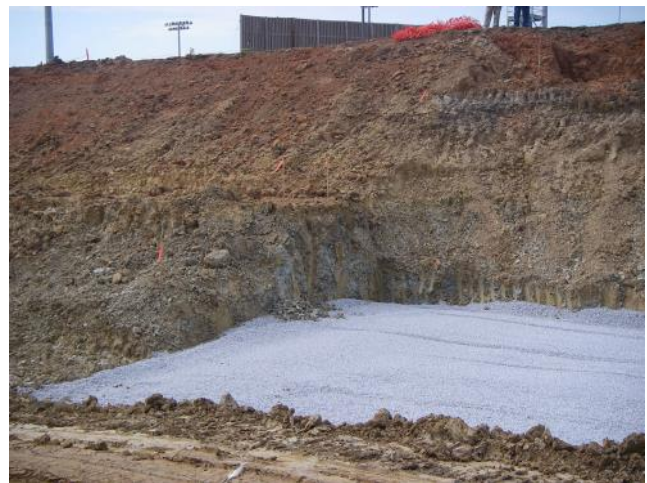
Figure 137. Eastern terminus of 230-foot-long crushed limestone keyway surrounded by Yazoo Clay at Millsaps College. Picture (digital, CD 46; Image 1033) was taken on June 17, 2008.

face was known, the wall had to be removed block by block (**Figure 135**), the Yazoo Clay in the slump block had to be excavated and removed, and a crushed limestone keyway was built through the failure surface to prevent further movement (**figures 136-137**). **Figures 138-139** show Burns Cooley Dennis' engineering plans for the construction of the new retaining walls, and **Figure 140** shows a construction-schedule conference with concerned representatives from the college, the construction firm, the engineering firm, and the Saints.

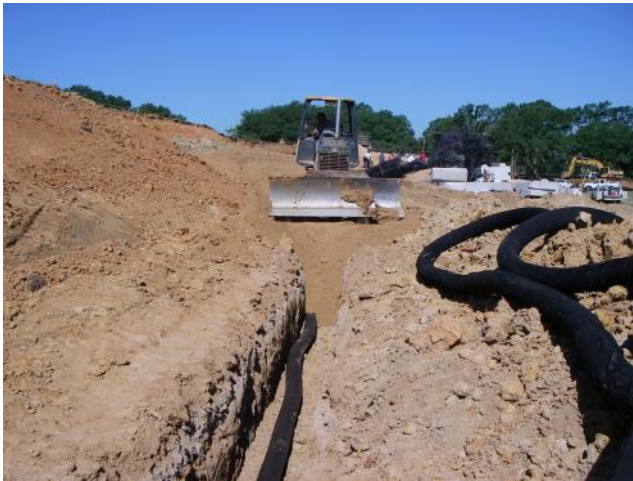
Figure 142. Bulldozer fills drain-line trench with sand to drain water away (to the east) from behind the upper retaining wall at Millsaps College. Picture (digital, CD 47; Image 1036) was taken on July 1, 2008.

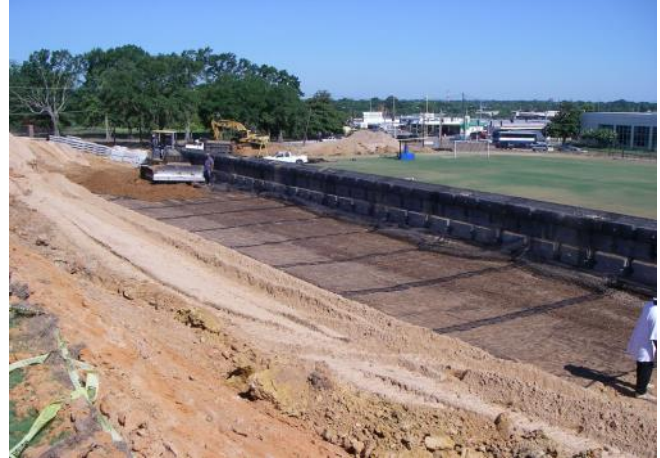
Figure 141. Geogrid plastic fabric is laid down behind the upper retaining wall at Millsaps College above a layer of sand fill. The sand chimney, which drains the cut face of the Yazoo Clay, can be seen along the left edge of the geogrid. The bulldozer is placing a silty soil above the geogrid. Picture (digital CD 47; Image 1037) was taken on July 1, 2008.

The design of the new wall required: (1) a significant crushed limestone keyway, extending below the failure surface, to lock the surface in place, (2) lower and upper retaining walls, (3) a sand chimney to drain the upper playing field (**figures 141-142**), (4) foundation-quality fill material, and (5) geogrid plastic to bind the fill as a unit. **Figures 141 and 143** shows the emplacement of fill and geogrid behind the upper wall. As this work progressed, it was determined (**Figure 144**) that the retaining walls needed to be extended an additional 115 feet to the east to protect the slope and drain the water from behind the walls. To ac-

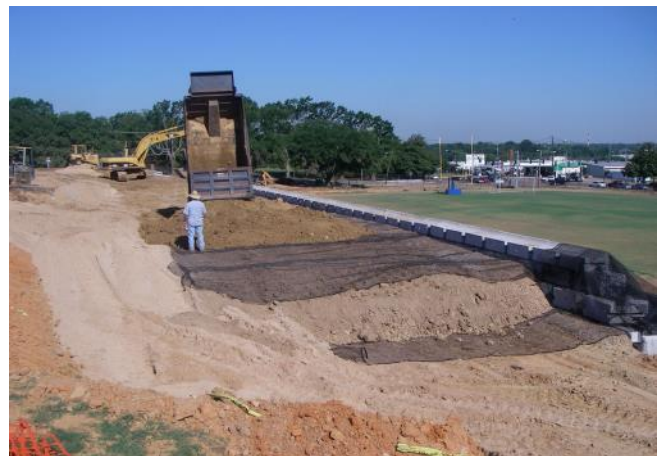
Figure 143. Layers of geogrid fabric and soil are placed behind the upper retaining wall at Millsaps College. The geogrid fabric ties the layers into a coherent block that resists the fractures and shearing responsible for slope failures. Picture (digital, CD 47; Image 1038) was taken on July 2, 2008.

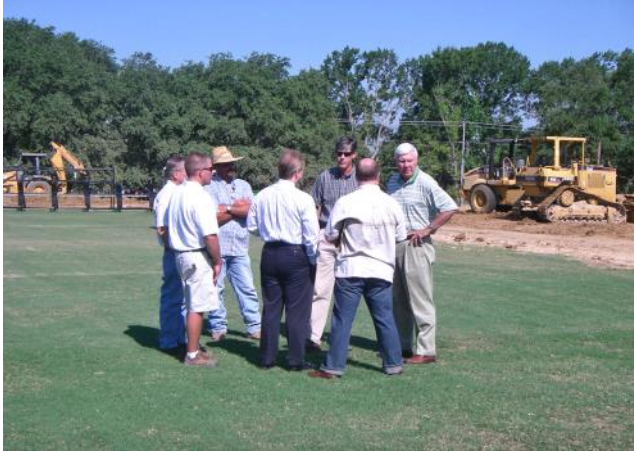
Figure 144. Work on the Millsaps retaining wall stops for a conference. The crushed limestone keyway must be extended eastward an additional 115 feet, bringing the total footage of the reconstructed keyway and lower retaining wall to 345 feet. At right and facing the camera are project engineers Eddie Templeton of Burns Cooley Dennis (in sunglasses) and, at far right, Charles Furlow of Soil Tech Consultants. Picture (digital, CD 47; Image 1039) was taken on July 2, 2008.

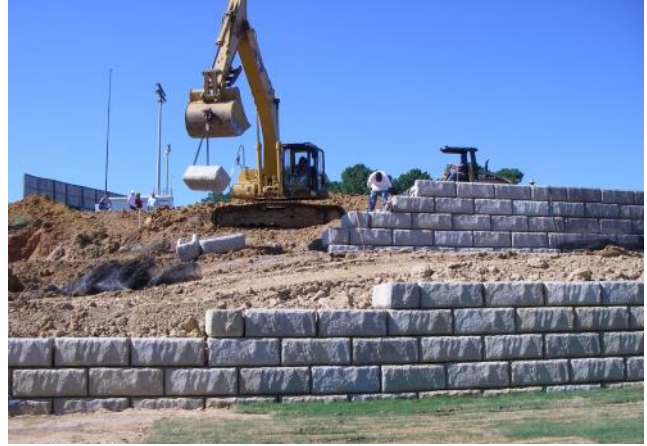
Figure 145. Extending the reconstructed upper wall at the Millsaps College football field from 205 to 300 feet long. First the end of the wall was dismantled, the Yazoo Clay was excavated, the crushed limestone keyway was extended, and then a sand chimney was placed behind the wall and fill dirt for drainage. Picture (digital, CD 55; Image 1067) was taken on July 15, 2008.

commodate this, the east end of the just built retaining walls had to be dismantled (**Figure 145**). **Figure 146** shows the new retaining walls upon completion. The moral of this event can be summed up in a comment overheard from one of the workers reinstalling the irrigation system; the first system was taken out when the main line was ruptured by the slump. The worker (**Figure 147**) said, "I'm doing the same thing I did last year." Put in terms of a carpenter's adage: Neglect geologic (soil) testing and build twice; do geologic testing and build once.

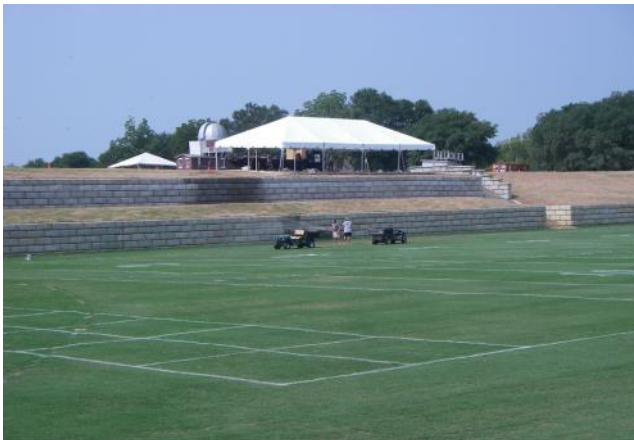
Figure 146. New retaining wall at Millsaps College completed in time for the Saints' summer football camp. The upper wall was extended from 205 to 300 feet to the east (left) of the stairs. Picture (digital, CD 55; Image 1066) was taken on July 22, 2008.

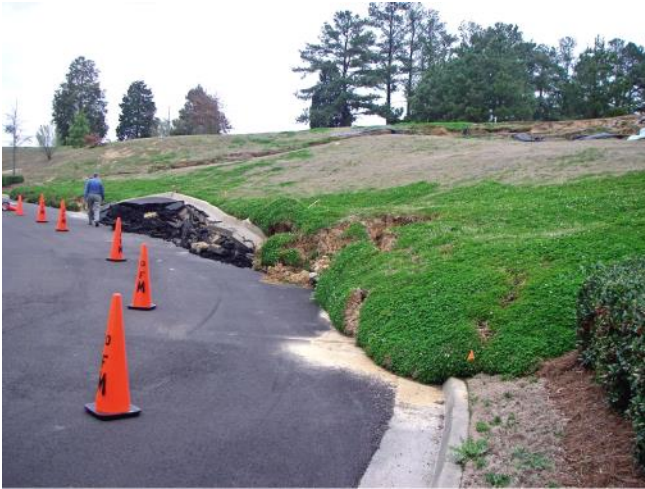
Figure 148. Michael Bograd inspecting road damage caused by a slump along a steep slope on the east side of the east entrance to Dogwood Festival on Highway 25 in Flowood, Mississippi. Picture (digital, DVD 59; Image 1214) was taken on February 27, 2009.

to an elevation of 350 feet above sea level with a terrace-sand deposit capping the hill top at 350 feet and above. Since the construction of the mall's east entrance, the slope has failed three times, the most recent failure occurring in February of 2009 (**Figure 148**). The 2009 slump event tore up a section of the road, curb, and storm drain, and required a permanent fix. In April of 2009 the failed soil of the slump was excavated (**Figure 149**) down to the unweathered Yazoo Clay bedrock (**Figure 150**) and removed. During and after dirt removal, (1) the cut was terraced, (2) a French drain was installed in the base of the cut and connected to the repaired storm drain, (3) the

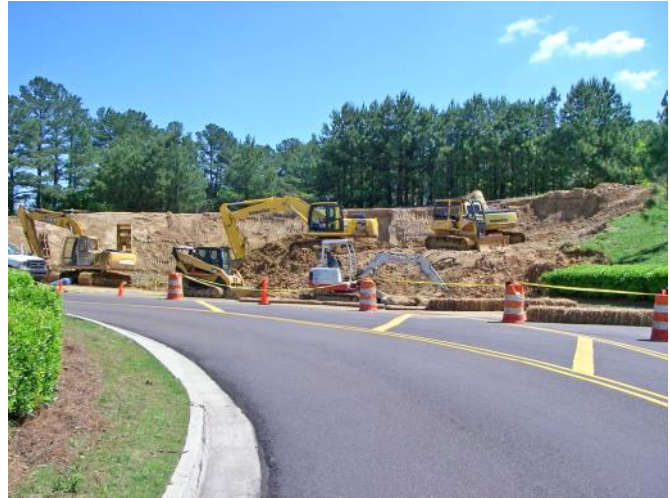
Figure 149. Excavation of slump on the east side of the entrance to Dogwood Festival on Highway 25 in Flowood, Mississippi. Picture (digital, CD 59; Image 1215) was taken on April 20, 2009.

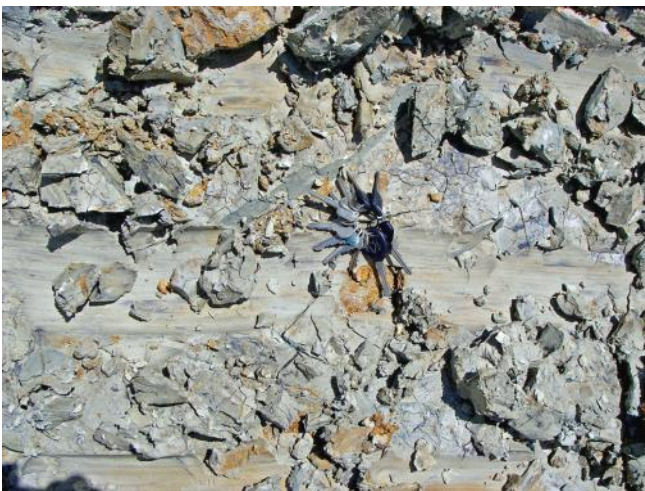
Figure 150. Unweathered Yazoo Clay in the bottom of excavation to remove slumped material along the east entrance for Dogwood Festival on Highway 25 in Flowood, Mississippi. Picture (digital, DVD 59; Image 1216) was taken on April 20, 2009.

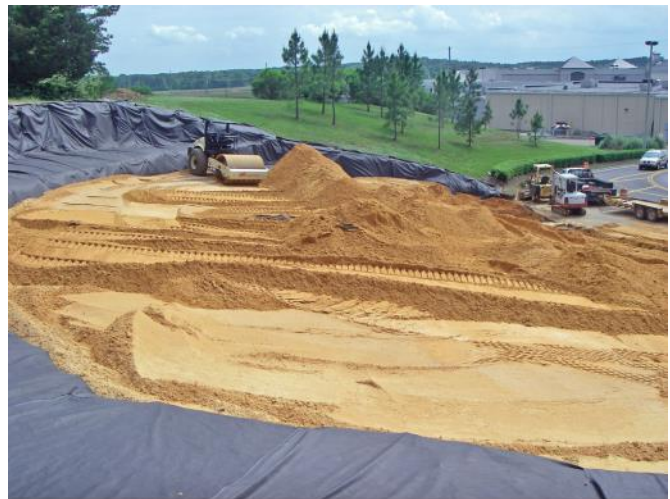
Figure 151. Slump excavation is sealed in fabric and backfilled and compacted with a 96% pure grade of sand. Dogwood Festival can be seen in the upper right. Picture (digital, DVD 59; Image 1217) was taken on May 1, 2009.

cut was lined with geotextile (also called geofabric) held in place with metal pins, (4) the cut was backfilled with a sand chimney and fill, using a sand with less than 4% silt (or a

greater than 96% pure sand) (**Figure 151**), (5) a retaining wall was installed with layers of geogrid and sand packed behind it, and (6) the sand chimney/fill was covered with fill dirt and top soil (**Figure 152**). Other than the sodding of the surface, the slump repair was largely completed in May of 2009.

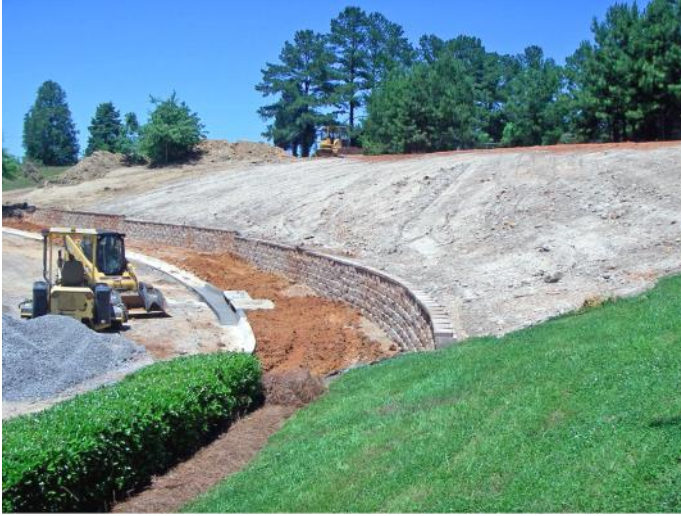
Figure 152. Slump repair near completion with the storm drain repaired, the retaining wall in place, and the sand fill covered with fill dirt. Picture (digital, DVD 59; Image 1218) was taken on May 18, 2009.

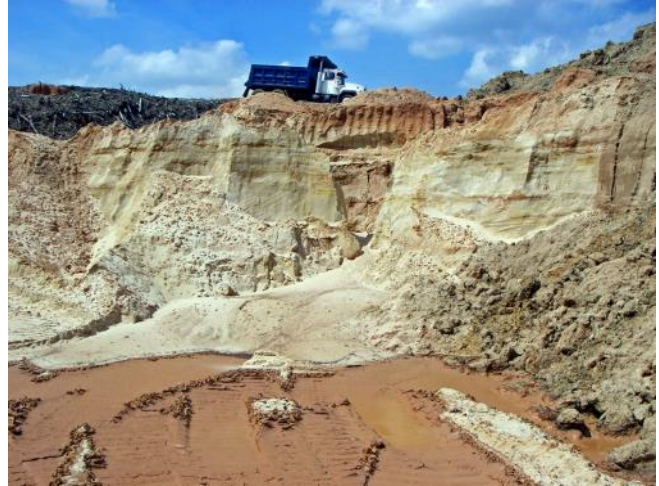
Figure 153. Sand pit in terrace sand at Flowood, Mississippi, operated by A & A Excavation Contractors, Inc.—the source of the fill sand for the Dogwood Festival slump repair. Sedimentary structures such as cross bedding can be seen in the pit's high-walls. Picture (digital, DVD 59; Image 1219) was taken on May 8, 2009.

The almost pure river sand used as fill for the slump repair came from a pit in a terrace deposit south of the Super Walmart on Highway 25. In **Figure 153**, a thick cross-bed set can be seen in the wall of this sand pit; similar sedimentary structures can be found in the point bars of modern rivers. Terrace sand is mined in several places along Highway 25 where it occurs at elevations between 350 and 400 feet above sea level and higher. This sand is usually of a reddish color and contains a greater silt and clay content than the sand shown in **Figure 154**. For a time, the 350-400-foot terrace sand composed a scenic butte at the entrance of Northwest Rankin Middle School (**Figure 7**), a setting that looked rather like an arid scene from the desert Southwest. This butte has been subsequently mined away.

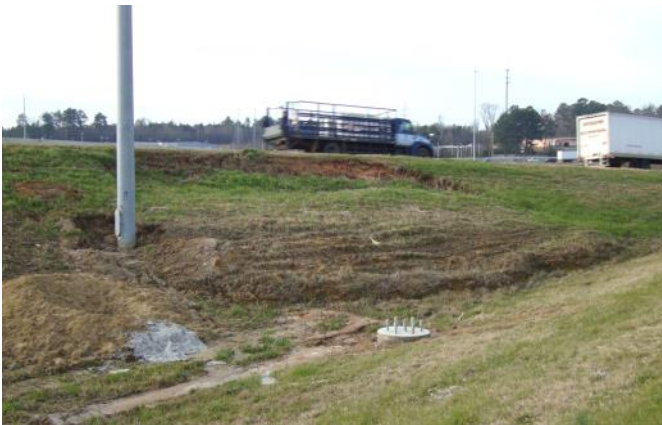
Figure 155. Slump in Yazoo Clay on the north side of Interstate 20 west of Gallatin Street. Picture (digital; Image 1438) was taken on February 10, 2010.

The I 20/Gallatin Street slump is a small one but has required frequent attention. This slump is sometimes patched up, and sometimes tolerated, but never fixed (**Figure 155**). The buff brown soil in the slump’s toe and seen in the mound of dirt drilled from the foundation of the light pole is weathered Yazoo Clay, which was perhaps used as fill in the construction of I 20.

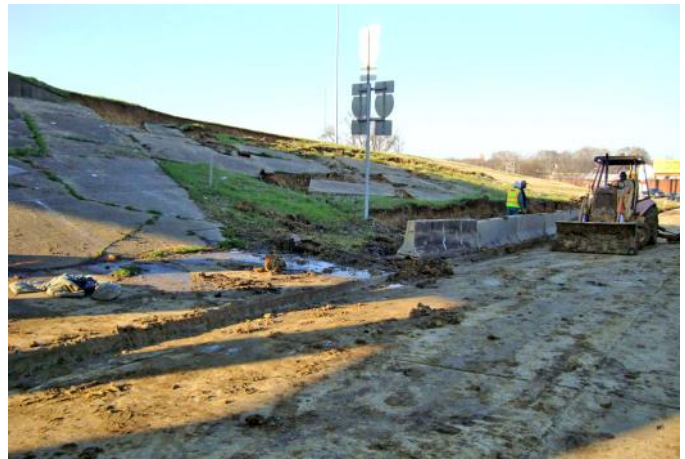
Figure 156. Work crew excavates slump toe from Terry Road at Interstate 20 and erects concrete barriers to keep the toe off the road. Picture (digital; Image 1439) was taken on February 9, 2010.

movement onto the road (**Figure 156**). The slump fragmented the concrete apron of the I 20 bridge abutment as seen in **Figure 157**. Bridge abutments along I 20’s right-of-way across the Yazoo Clay outcrop belt have had similar problems, as is evidenced by the rip-rap buttresses at bridge abutments beginning at Lake in Newton County to the east and continuing westward to just west of the I 20/I 220 interchange. One slope repair on the north side of I 20 near Forest, Mississippi, has a large rip-rap buttress and a system of underground and above-ground drains (**Figure 158**). The cost of this repair was such that one state worker claimed that for less money he could hire a bulldozer operator to work 24-7 to

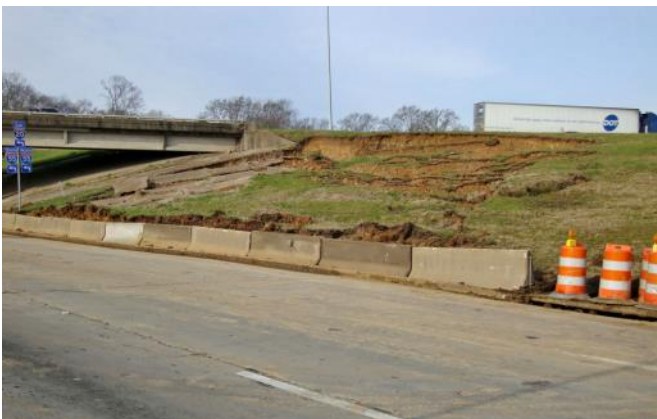
Figure 157. Slump in Yazoo Clay on Terry Road at Interstate 20 in Jackson. Concrete barriers keep the slump toe off the road; the slump has fractured the concrete apron under the I-20 bridge. Picture (digital; Image 1440) was taken on February 10, 2010.

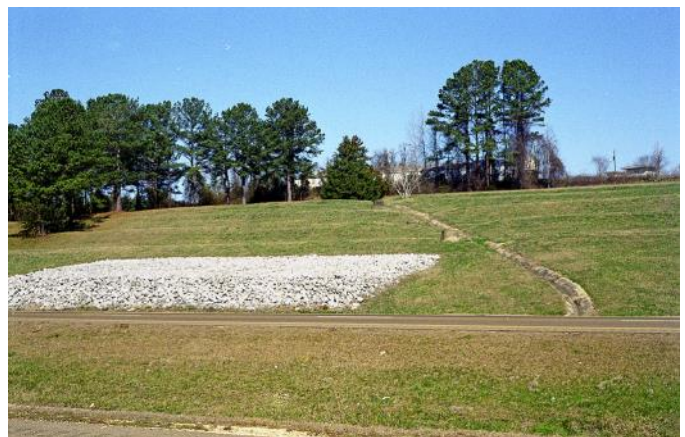
Figure 158. Rip-rap and concrete drain installed to prevent slumping in the Yazoo Clay on a road cut north of the Interstate 20 west-bound lane near Forest, Mississippi. Picture (color negative 568-0A; Image 344) was taken on March 1, 2006.

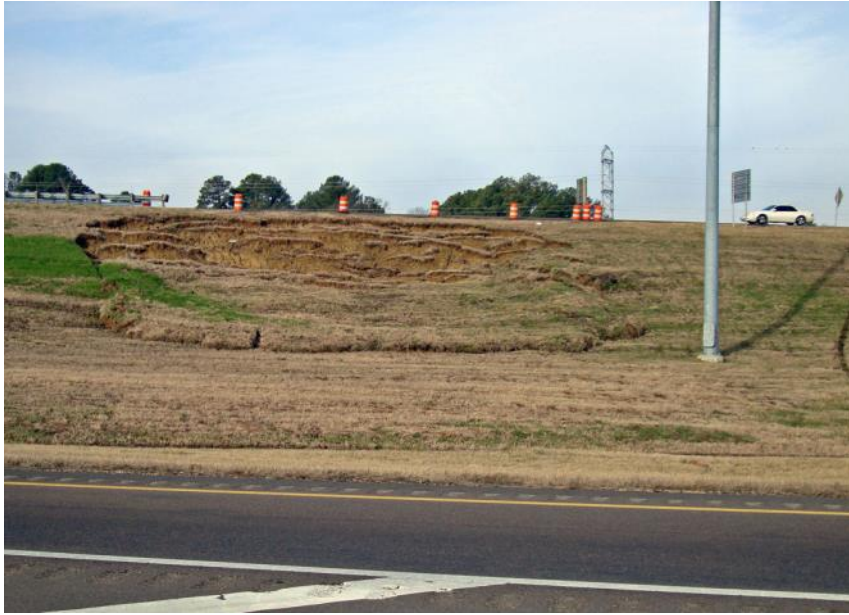
Figure 159. Slump in the Yazoo Clay on the east side of Interstate 220 South near the I-20 interchange. Picture (digital; Image 1441) was taken on February 10, 2010.

The I 220/I 20 slump is new (**Figure 159**), but rip-rap to the south of it tells of a nearby slump that MDOT recently repaired with buttressing fill material (and the rip-rap toe). Together these slopes show that the interstate east slope is too steep. The Yazoo Clay involved in this slope failure may have been used as fill in the construction of this section of I 220; if so, it is Yazoo Clay fill on Yazoo Clay “bedrock.”

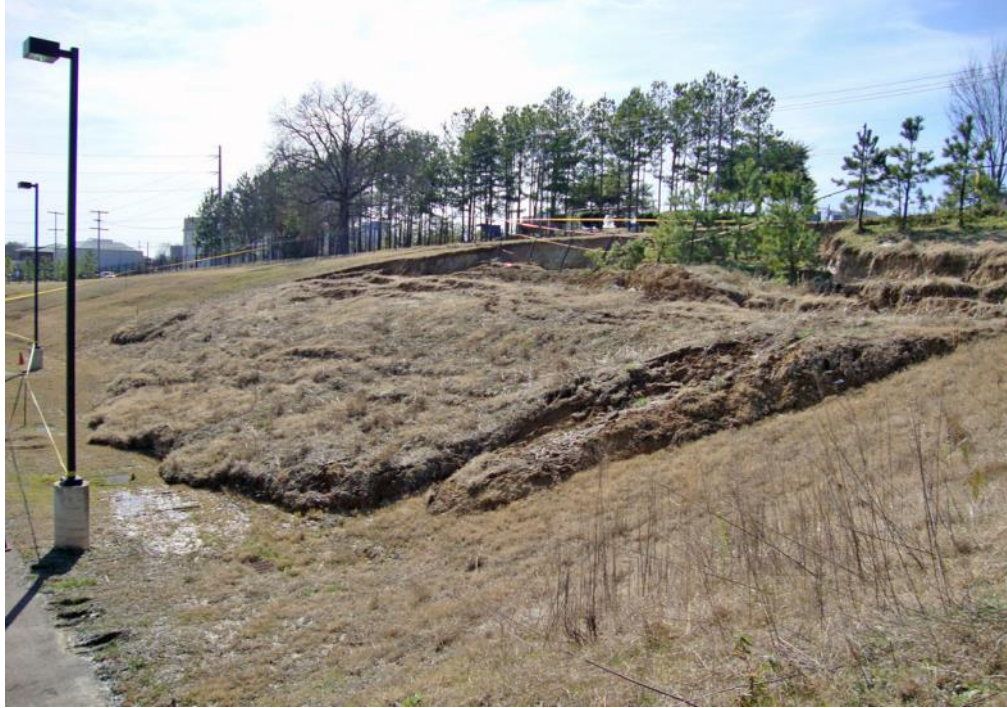
Figure 160. Slump in Yazoo Clay behind the new Farmer's Market. The slump scarp at top threatens a water main and Jefferson Street. Picture (digital; Image 1442) was taken on February 18, 2010.

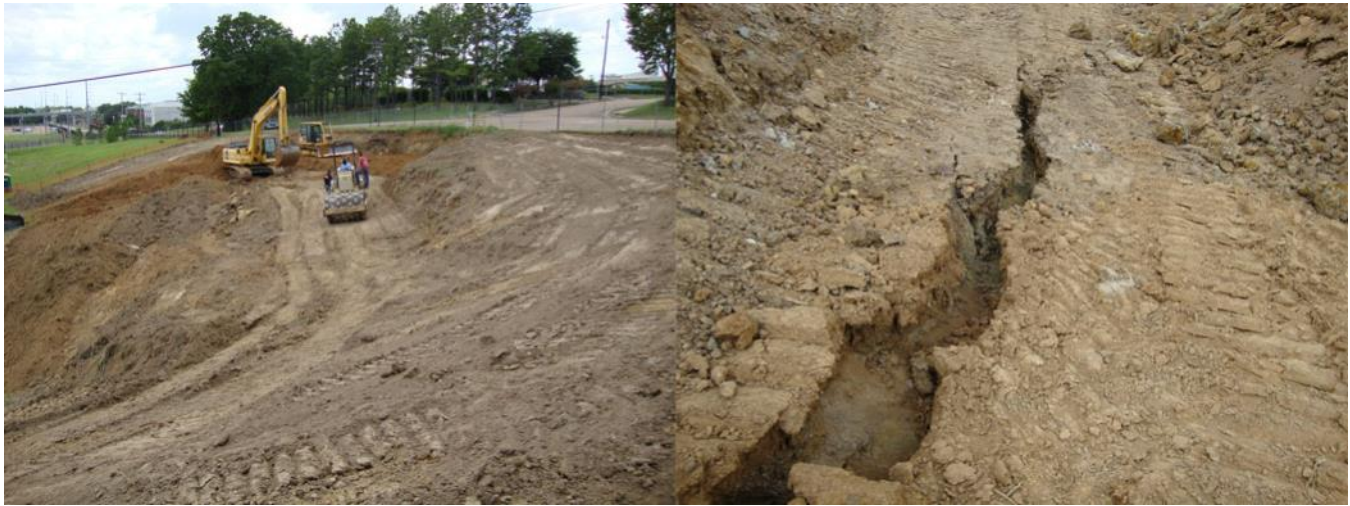
Figure 162. Left: Adding and compacting fill material to the upper slope behind the Farmer's Market on July 19, 2010. Right: New failure in the Yazoo Clay of the upper slope the following day on July 20, 2010. Pictures (digital; Composite Image 1681).

On April 8, 2009, I went to see the newly repaired slope below Jefferson Street and behind the Farmer's Market parking lot. Yazoo Clay had been removed from the failed slope and replaced with non-expansive fill dirt, which was freshly landscaped at the time. Less than a year later on February 10, 2010, I returned to see a complete failure of that same slope (see the May 2010 issue of *Environmental News*, page 20). At risk were the Farmer's Market parking lot, Jefferson Street, and water mains beside and under Jefferson Street. The repair design to fix the failed slope was a shot-

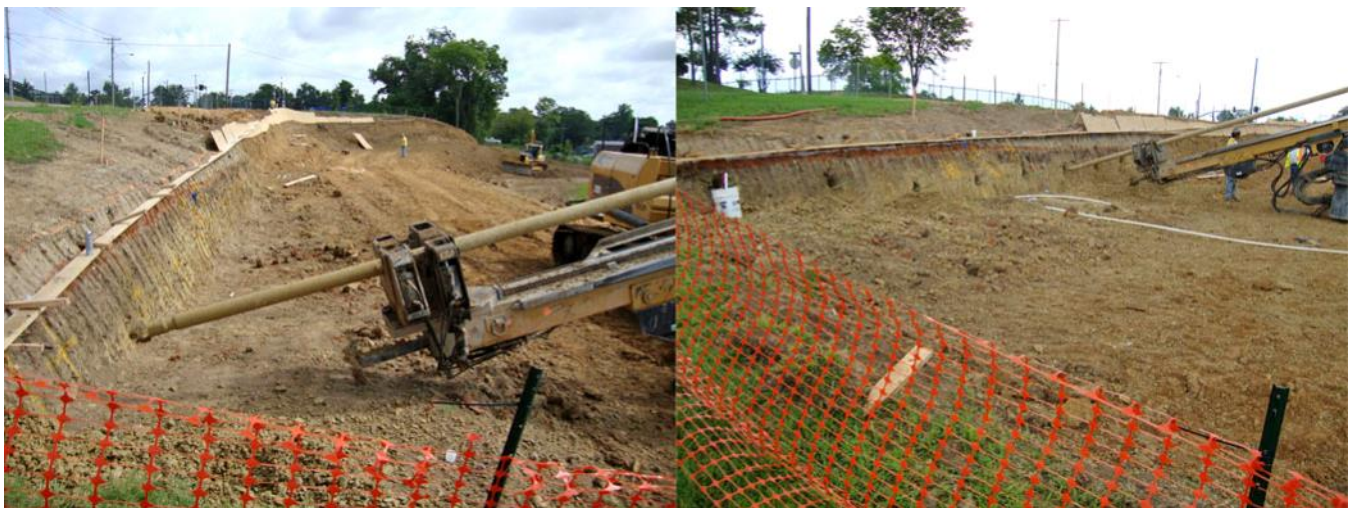
Figure 163. Left: The yellow cross marks the spot for drilling the hole for the second soil nail in the upper tier of the Farmers Market retaining wall. Right: Rebar protrudes from five holes, while a sixth hole is being reamed out. The white hose is for pumping grout. Pictures (digital; Composite Image 1682) were taken on July 28, 2010.

crete wall anchored by soil nails. The term “soil nail” is not the most reader-friendly term to explain the structures that secured the wall. Soil pilings better describe the 35 to 45-foot-long grouted-rebar structures that are drilled, inserted, and grouted at a 10-20 degree angle to the horizon. Some 160 soil nails were placed to hold the shotcrete wall, a welded-wire-mesh-reinforced wall that would be only about 6 inches thick. A photographic record of the wall’s construction was kept from July 19 to August 16, 2010, as shown in the accompanying figures.

The upper tier of the wall was constructed first with soil nails at a 20-degree slope below the horizon and on centers spaced four to five feet apart. The middle and bottom tiers of the wall had soil nails with a 10-degree slope and with a similar spacing. Soil nails had a vertical spacing of about five to six feet. The finished wall had a 1 to 2 slope, one foot horizontal for two feet vertical, and the grassed slope at the base of the wall was 6 to 1, six feet horizontal for each foot vertical. **Figure 162** shows the dirt work in preparation for the wall construction. **Figures 163-165** show the construction of the wall’s upper tier. After this

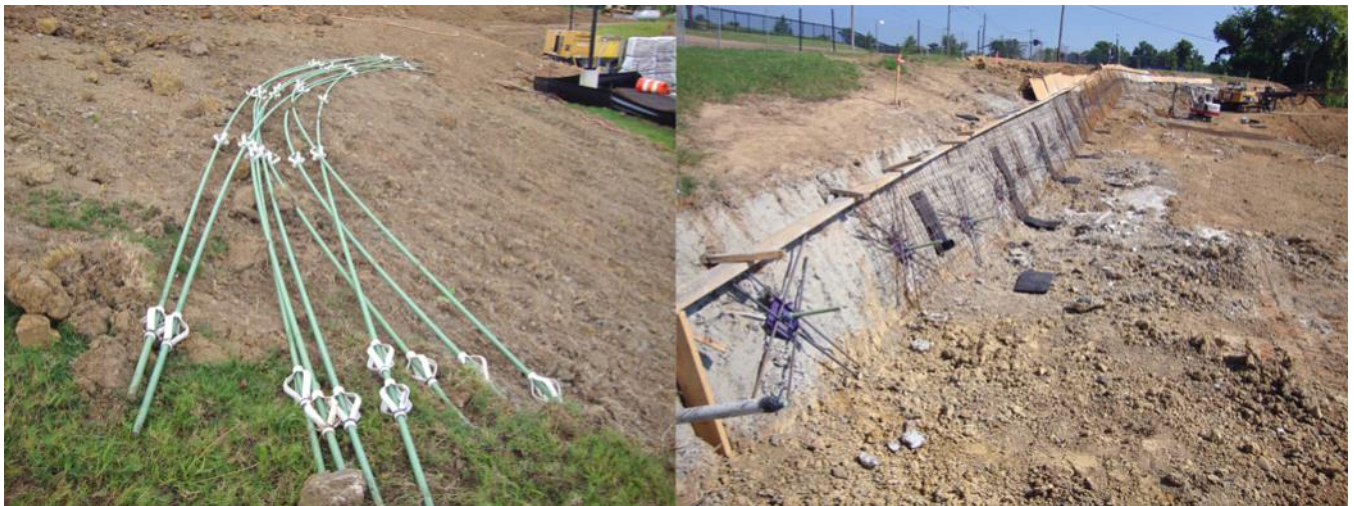
Figure 164. Left: Rebar and spacers for soil nails. Right: Forms, grouted rebar (soil nails), and welded wire mesh of the upper tier of the Farmer’s Market retaining wall. Pictures (digital; Composite Image 1816) were taken on July 28 (left) and July 31, 2010.

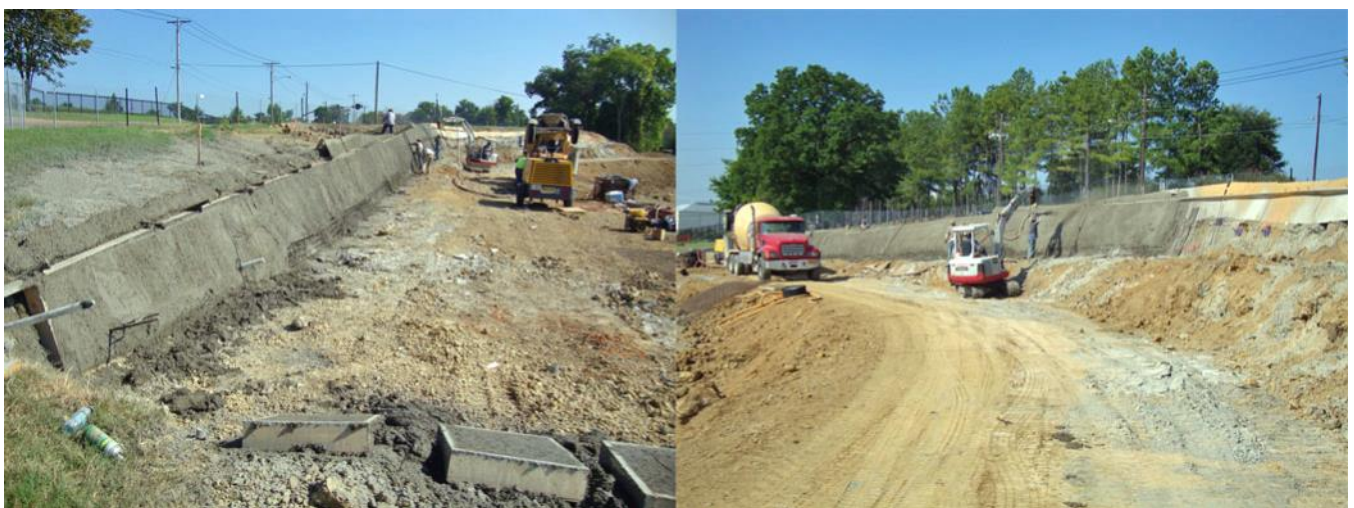
Figure 165. Left and right: Spraying shotcrete onto the welded wire mesh of the upper tier of the Farmer’s Market retaining wall. Pictures (digital; Composite Image 1817) were taken on August 2, 2010.

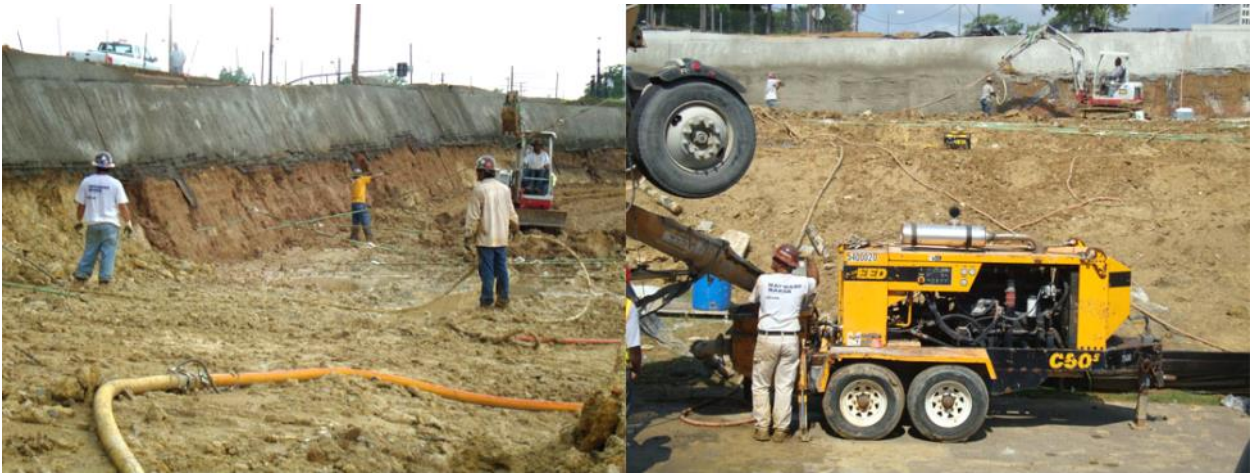
Figure 166. Left: Workers hurry to insert rebar into drill holes in the south end of the middle tier after an afternoon storm sends water pouring in from behind the wall at the contact of the brown Yazoo Clay and red fill dirt just to the right of the man at far left. A leak in a 6-inch city water main was discovered, which contributed to the flow; the leak was repaired by the city that evening. Right: Cement truck pours shotcrete into hopper where it is pumped through a hose and sprayed onto the soil nails and welded wire mesh on the troubled south end of the middle tier to seal the leak site behind the Farmer's Market retaining wall. Pictures (digital; Composite Image 1818) were taken on August 4 (left) and August 6, 2010.

construction, an afternoon storm complicated work as water poured out from behind the wall at the contact of the Yazoo Clay and adjacent fill material (**Figure 166**, left picture). When the rain stopped, the water flow continued, leading to the discovery of a leak in a 6-inch city water main behind the wall. This leak was repaired by the city, and the leaky south end of the middle tier was sealed with shotcrete.

Figures 166 and 167 show the construction of the middle and lower tiers of the retaining wall, including the effort to insert rebar into drill holes after a rainstorm. **Figure**

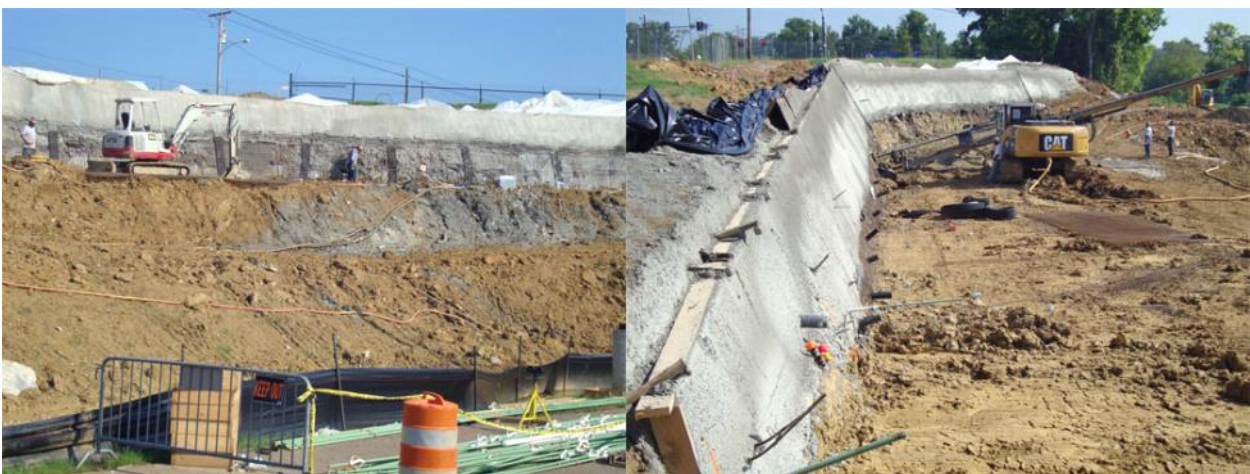
Figure 167. Left: Welded wire mesh is checked before shotcrete is sprayed on the north end of the wall's middle tier. The black vertical strips are drains to prevent the accumulation of water behind the wall. Right: Holes are drilled for the soil nails of the lower tier of the Farmer's Market retaining wall. Drain pipes are visible at the base of the wall. Pictures (digital; Composite Image 1819) were taken on August 9 (left) and August 11, 2010.

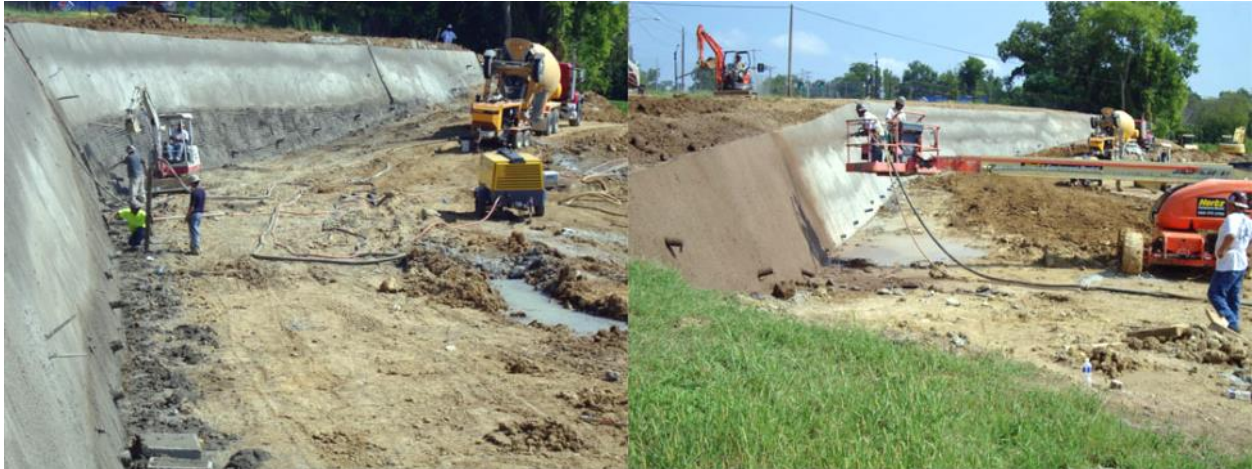
Figure 168. Left: Shotcrete is sprayed onto the welded wire mesh of the lower tier of the Farmer's Market retaining wall. Right: A brown dirt-colored grout is sprayed over the entire retaining wall to give it a natural appearance (like dirt). Water drains can be seen protruding from the base of the wall. Pictures (digital; Composite Image 1820) were taken on August 12 (left) and August 16, 2010.

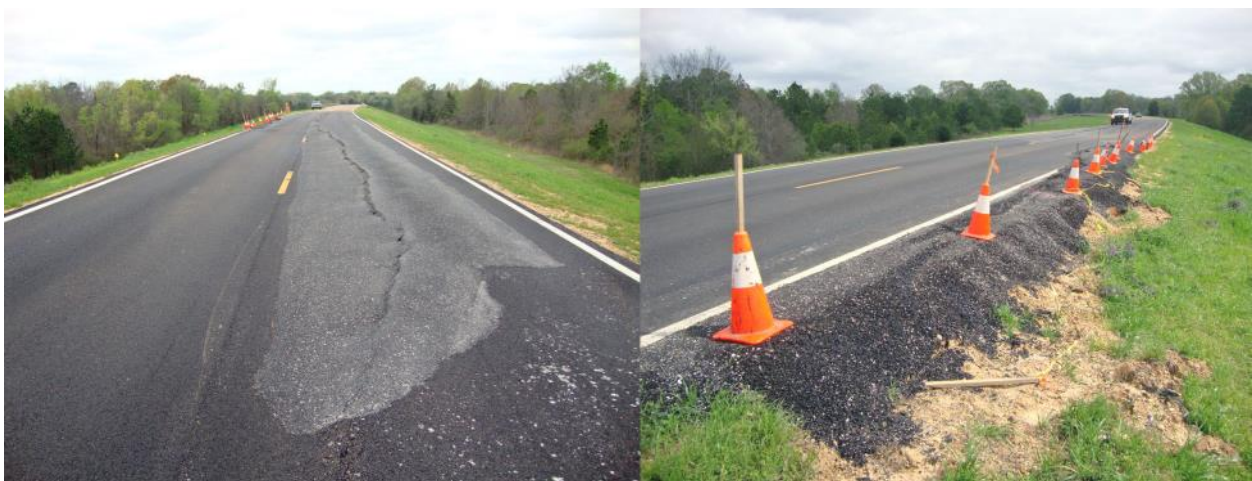
Figure 169. Failed road surface on the Natchez Trace Parkway along a steep slope near the County Line Road overpass in Jackson, Mississippi. Pictures (digital; Composite Image 2243) were taken on March 14, 2012, the day before the road was closed to traffic.

Just seven years after opening, a portion of the Jackson bypass route was closed on March 15, 2012, due to a slope failure on the Yazoo Clay near milepost 94.8 just south of where the Trace crosses West County Line Road. In 2011, the roadway at this point developed a large crack that separated the two lanes of traffic. Several repairs were made to the road surface that year, but movement along the crack continued to the point that the road was deemed unsafe for vehicular traffic (**Figure 169**). Some 13,000 cars per day travel the Natchez Trace between Jackson and Clinton; it was feared such heavy traffic could contribute to the road problem. Repairs were estimated to take about a year and to cost about one million dollars.

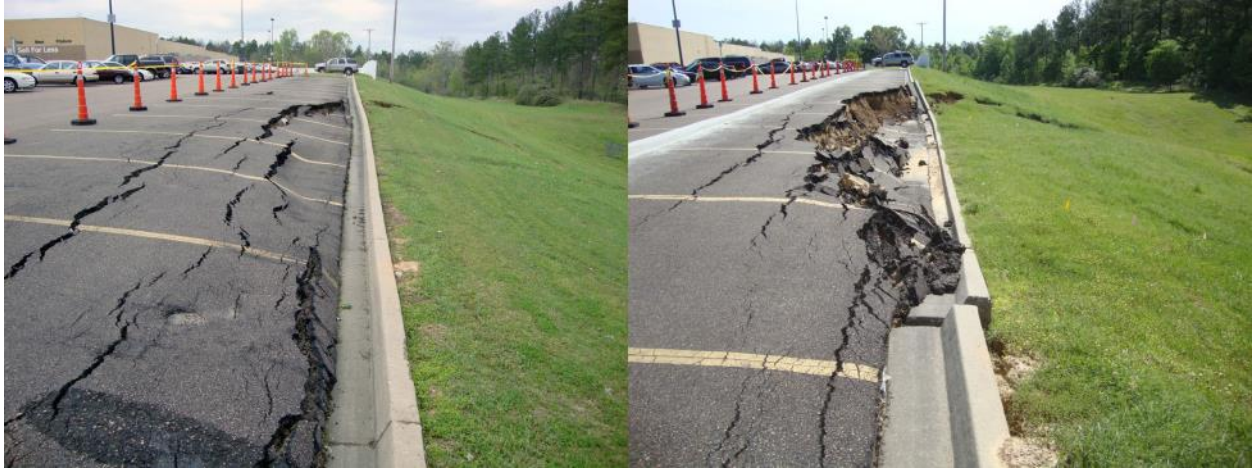
Figure 170. Progressive slope failure on the west side of the Walmart parking lot on Highway 80 in Clinton, Mississippi. The picture on the left was taken on March 14, 2012, and the picture on the right with the addition of a set-back concrete curb was taken on April 9, 2012 (Composite Image 2244).

The west slope bounding the Clinton Walmart parking lot on Highway 80 began a slow and progressing failure at the beginning of 2012. At first, warning cones were placed around the failure; added to this was a concrete curb offset some 15 feet from the failed curb (**Figure 170**). The toe of the slump filled in part of the store's storm-water runoff basin, and the scarp on the south flank deflected the original curb and water line at a 30 degree angle (**Figure 171**). The scarp on the north flank of the slump pulled on optical fiber cables (communication lines), displaced the power pole, and displaced a gas line (**Figure 172**).

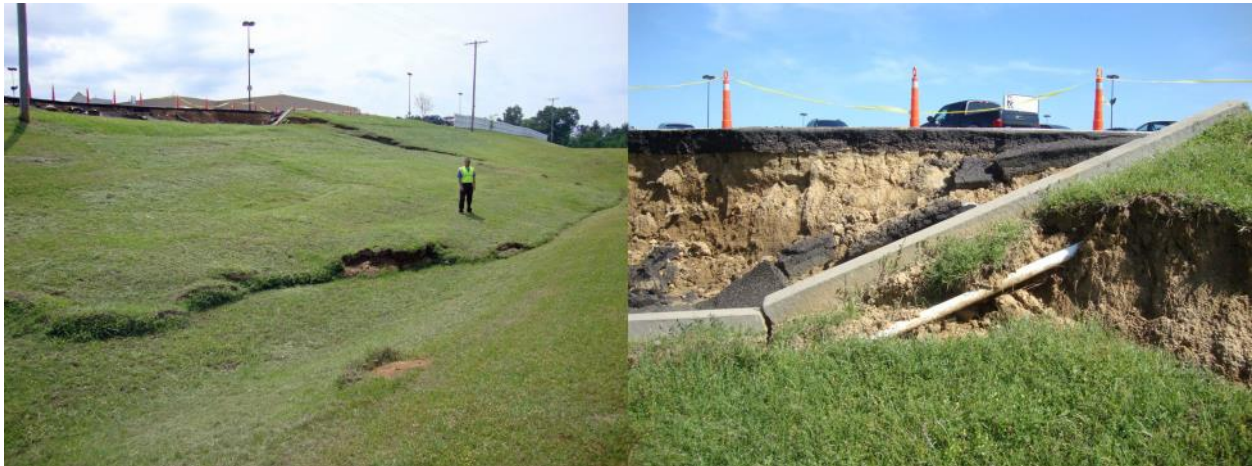
Figure 171. The toe of the slump at left fills part of the store's storm-water runoff basin. The scarp on the slump's south flank has deflected the original curb and water line at a 30 degree angle. The picture on the left was taken on April 10, 2012, and the picture on the right was taken on April 9, 2012 (Composite Image 2245).

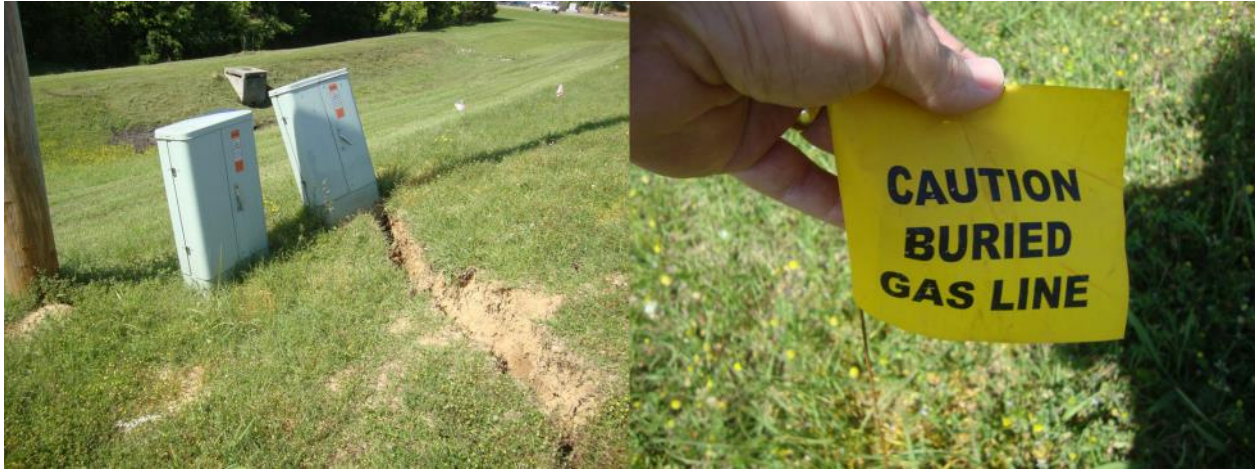
Figure 172. At left, the scarp on the slump's north flank cuts at the base of a telephone cable box, displaces a power pole, and (at right) cuts across a buried gas line. Pictures (digital; Composite Image 2246) were taken on April 9, 2012.

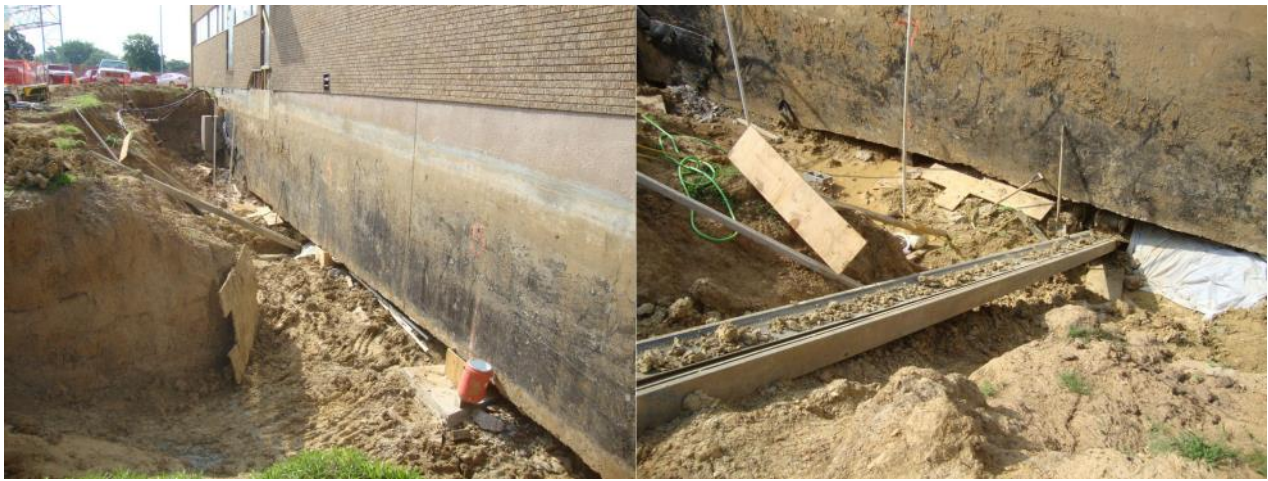
Figure 173. At left, the exterior wall of the Department of Public Safety rests on new pilings; a water cooler rests on the nearest piling, which is marked with the number 5 above. At right, a conveyor belt removes Yazoo Clay as workers dig a new crawl space beneath the floor slab. Picture (digital; Composite Image 2247) were taken on May 7, 2012.

tion of Interstate 55 and Woodrow Wilson Drive underwent repairs this year after the Yazoo Clay closed the crawl space under the floor and lifted the floor and its 20-foot-deep pilings and lifted and sheared the exterior wall from its pilings. New pilings were constructed for the exterior walls, and a new crawl space was dug under the floor. **Figure 173**, at left, shows an exterior wall set on new pilings, and, at right, a conveyor belt removing weathered Yazoo Clay as workers dig a new crawl space. **Figure 174**, at left, shows the remains of one of the original exterior pilings and, at right, shows the offset between the floor slab, which was lifted by the Yazoo Clay, and the exterior walls.

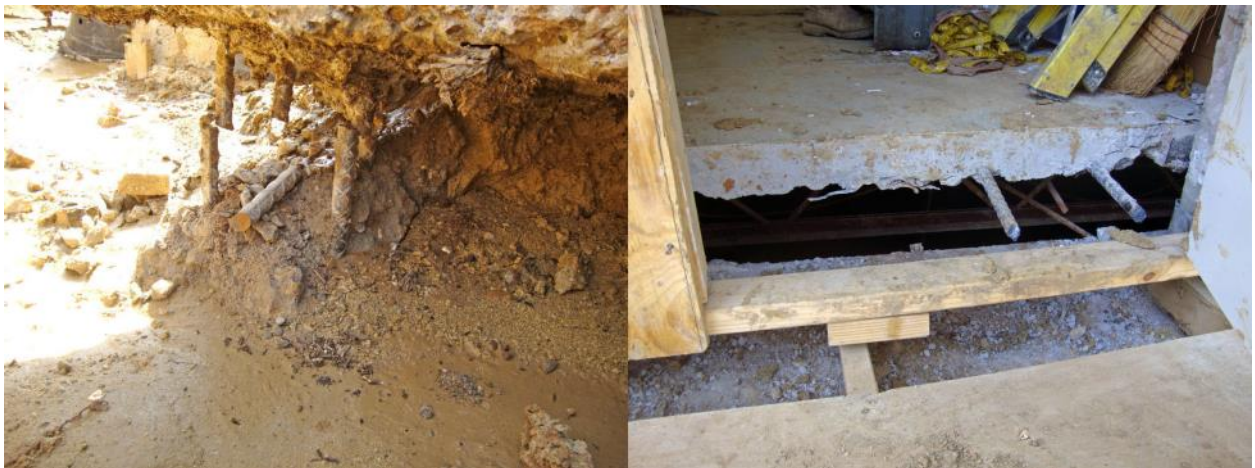
Figure 174. At left is the remains of one of the original exterior wall pilings. At right is the floor slab, which has been lifted about half a foot above its original position in relation to the exterior wall. Pictures were taken on May 7, 2012.

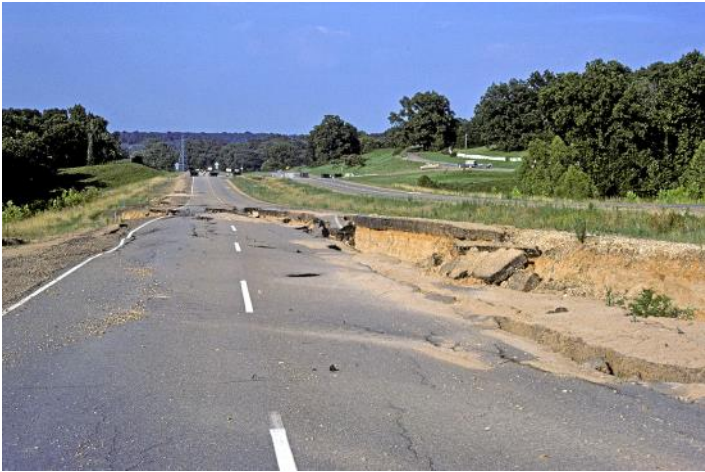
Figure 181. Failure of Highway 61 southbound lane in Vicksburg, Mississippi, south of Interstate 20 due to a large slump in the loess overlying the Bucatunna Formation. Picture (Kodachrome slide 15-21; Image 538) was taken on May 31, 1978, as viewed looking north.

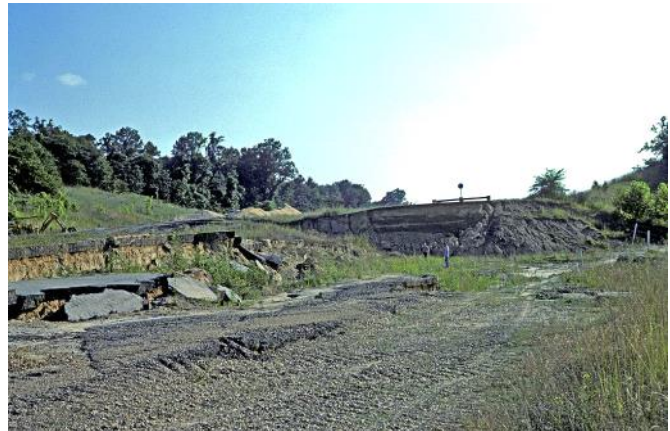
Figure 182. Failure of the Highway 61 southbound lane in Vicksburg south of Interstate 20 as viewed looking south. Here a large slump in the loess has caused a drop of about 20 feet where the fault scarp cut the highway. Picture (Kodachrome slide 15-20; Image 539) was taken on May 31, 1978.

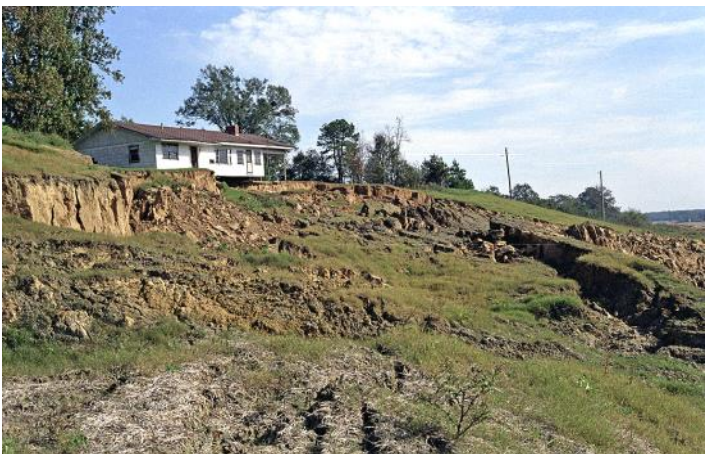
Figure 183. Slump in loess and underlying Miocene clays cutting into the foundation of the Keating house on Highway 61 at Cannonsburg in Jefferson County. The slump occurred when the toe of the hill was cut to expand the highway. Picture (color negative 536-20; Image 334) was taken on November 16, 2004.

in 2006 to prevent a potential slope failure. Work on the new four-lane section of Highway 61 at Cannonsburg in Jefferson County in the fall of 2004 caused a slump in loess overlying a smectitic Miocene clay, which undercut the foundation of the Keating house on the hilltop above (Gates, 2004; Dockery, 2005) (**Figure 183**).

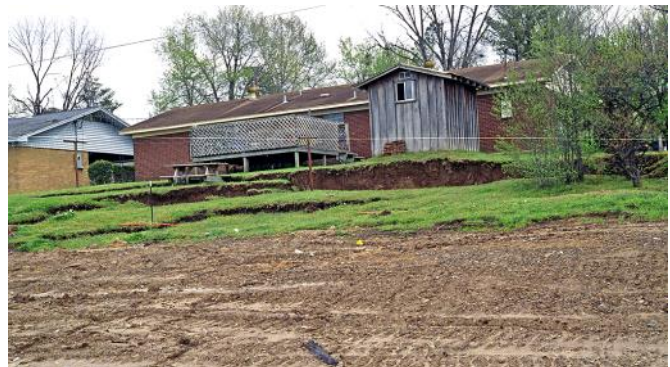
Figure 184. Slump in loess at Vicksburg, Mississippi, where the toe of the slope was cut during the construction of a new railroad track. Picture (color negative 574-23; Image 317) was taken on March 21, 2006.

located along the railroad right-of-way (**Figure 184**). Residents of a nine-block area along Pearl Street were warned to prepare for evacuation should additional mudslides occur (Hinton, 2006). A substantial retaining wall was built at the back of the Ameristar parking lot in Vicksburg to hold the base of a loess bluff in place (**figures 185-186**).

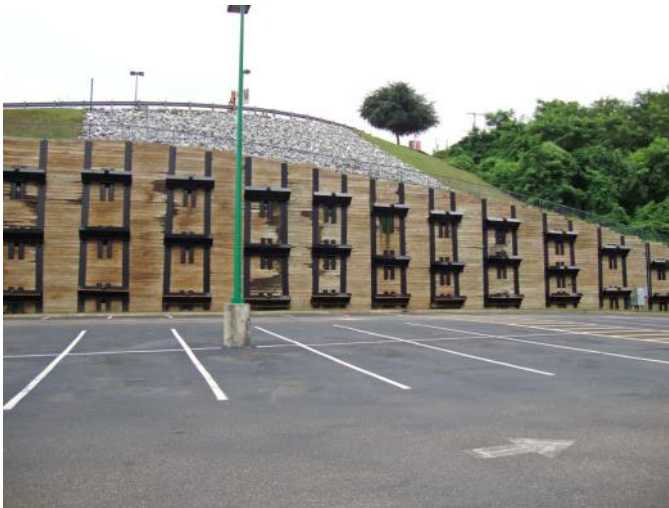
Figure 185. The Ameristar parking lot and retaining wall cut into the loess bluff adjacent the Mississippi River at Vicksburg, Mississippi. Picture (digital, DVD 98; Image 1877) was taken on September 9, 2009.

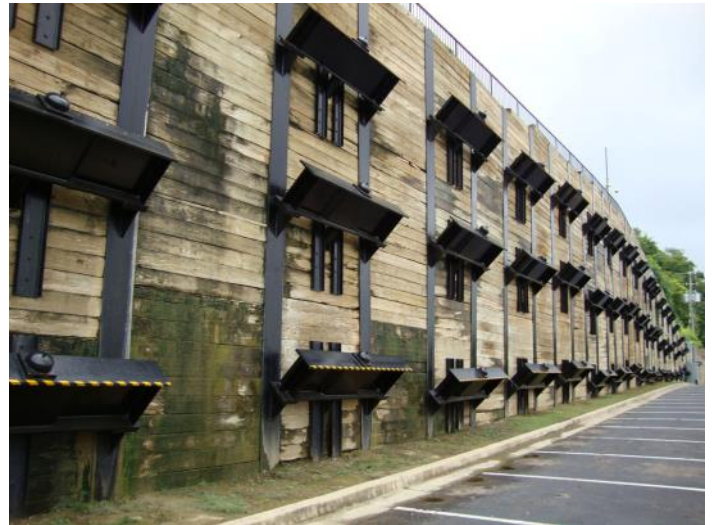
Figure 186. Retaining wall, consisting of soil nails, steel framework, and treated wooded planks, at the toe of the loess bluffline at the Ameristar Casino in Vicksburg, Mississippi. Picture (digital; Image 1330) was taken on September 26, 2010.
